Common Deck Defects

Here's a look at the framing and flashing details that contractors keep getting wrong

by Bruce Barker

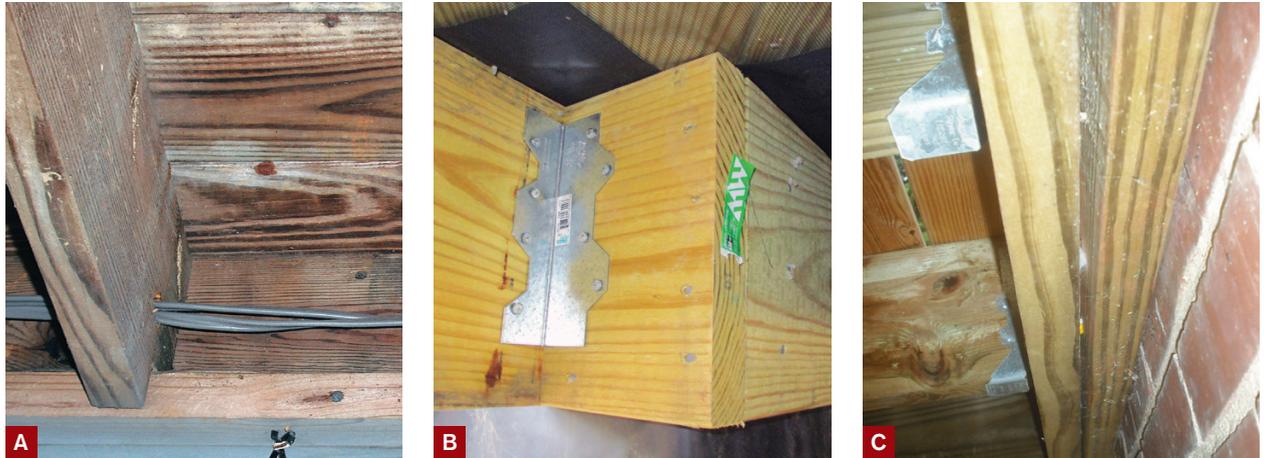
Figure 1. Older decks frequently have ledgers that have been nailed rather than screwed or bolted to the house (A), but the author sometimes finds this problem on recently built decks too (B). Note the nailed double-ledger connection, which is in the process of separating, in photo (C).

find ledgers that have been nailed to the framing, which is prohibited by both DCA 6-15 and the IRC (**Figure 1**). When I do, I complete my inspection, then explain the risks to my clients and advise them (and their real estate agent) not to walk on the deck until it is properly attached to the house. In my report, I highlight this defect in red ink to emphasize the importance of this finding and recommendation.

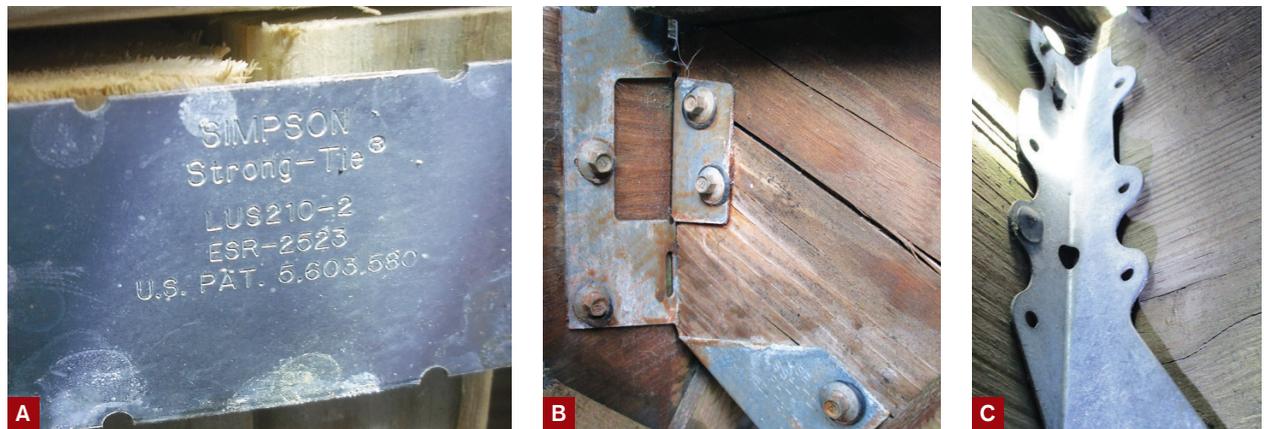
Figure 3. White rust is already forming on this joist hanger, which is only approved for interior use (A). Metal-roofing screws aren't approved joist-hanger fasteners (B), nor are roofing nails (C); all of the holes in metal hardware should be filled with approved hanger nails or structural screws, and the hanger flanges should fit snugly against the joist (D). Metal hardware shouldn't be field-modified; with its seat removed, this hanger provides minimal joist support (E).

I often find problems with joist hangers and other metal hardware. Sometimes the deck builder has used hangers intended for interior use, when he or she should have used G185 (minimum) galvanized hangers, or even stainless steel hangers in coastal areas. One way to verify that a Simpson Strong-Tie joist hanger is suitable for use on a deck is to look for a Z (galvanized) or an SS (stainless steel) at the end of the model number (**Figure 3**).

It's not unusual to see joist hangers fastened to the framing with roofing nails or drywall screws. Hardware manufacturers typically specify the type and size of fasteners that must be used with their products; in general, screws—except those specifically allowed by the manufacturer—should not be installed, nor should you mix metals.

Curiously, I often find hangers installed with just two or three fasteners. In almost all cases, joist hangers should have a manufacturer-specified fastener in every round and oblong hole.

I often find field-modified hardware too, but in most cases, joist hangers and other hardware should not be bent unless the manufacturer allows bending. Even then, the hardware should be bent only once to the required position.

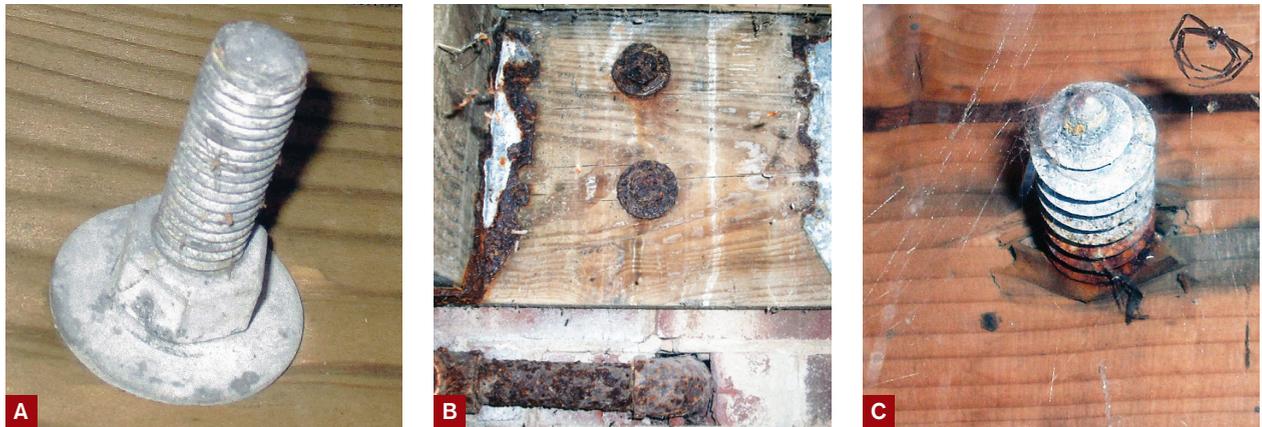
Figure 4. The white rust on this ledger bolt indicates that it is still safe but is nearing the end of its service life (A). The extensive red rust on these bolts indicates that the hardware should be replaced immediately (B). Water intrusion is causing wood rot and the red rust on this lag bolt; the connection is likely weakened (C).

One of the most important things I look for when inspecting a deck or balcony is white or red rust. White rust appears on metal hardware as white stains, indicating that the protective zinc coating (galvanization) is deteriorating. While white rust indicates that hardware is nearing the end of its service life and should be monitored regularly, significant red rust indicates that the component has reached the end of its service life and should be replaced (**Figure 4**).

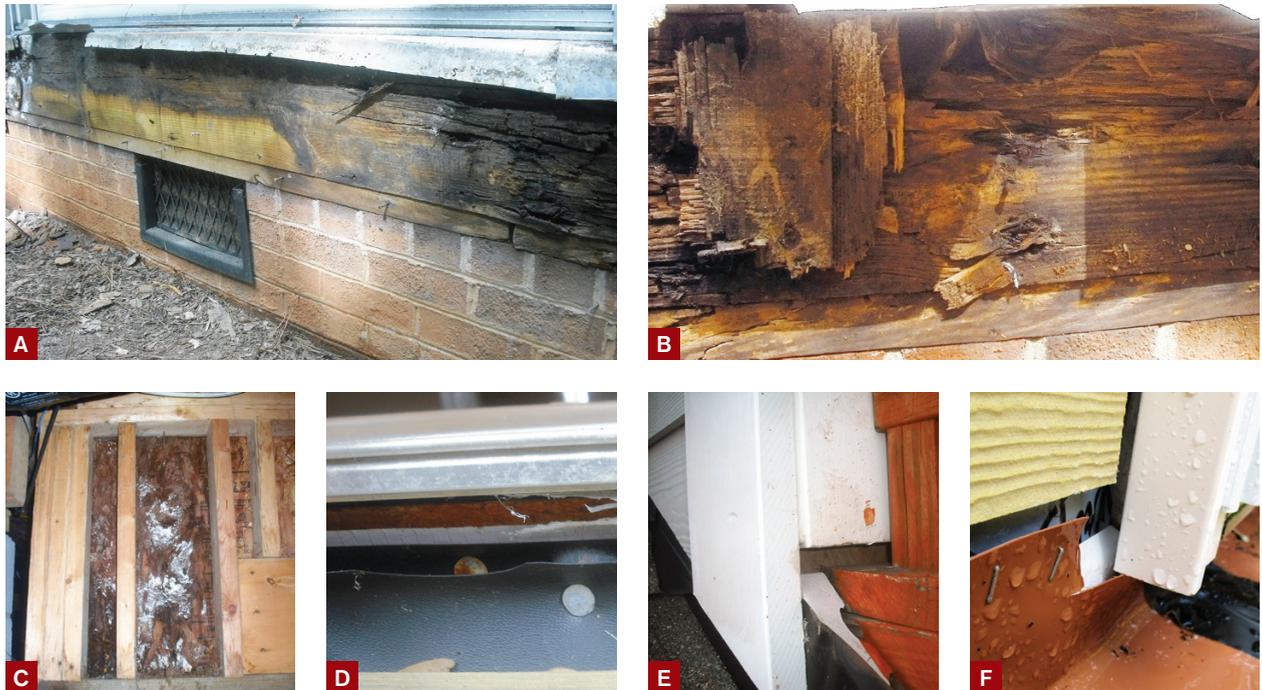
Figure 5. The sheathing and band joists on these homes (A, B) are in rough shape, thanks to moisture intrusion from their decks, and require replacement. Improperly installed ledger flashing on a one-year-old deck was the cause of this water damage (C). Flashing is often improperly installed underneath door thresholds (D) and where ledgers intersect with other building components, such as a roof (E). During a new-home inspection, the author discovered flashing that hadn't been integrated with the water-resistant barrier underneath the home's siding (F).

It won't matter how well a deck ledger is attached to a building if the band joist or rim board it's attached to is water-damaged. The bolts or screws may withdraw from water-damaged wood, and if this occurs, the deck will collapse. Even though flashing details are not spelled out in the IRC, properly installed deck flashing is essential for the long-term structural integrity of a deck (**Figure 5**).

When I inspect a deck, I look for deck flashing that is integrated into the wall drainage system and into the flashing for wall penetrations, such as doors, that open on to the deck. The objective is to direct water away from vulnerable wood and away from entry points into the building, but builders often get the details wrong, with serious—and sometimes catastrophic—consequences. Seemingly minor flashing errors can admit a lot of water into a wall assembly.
